Dux Quest

History

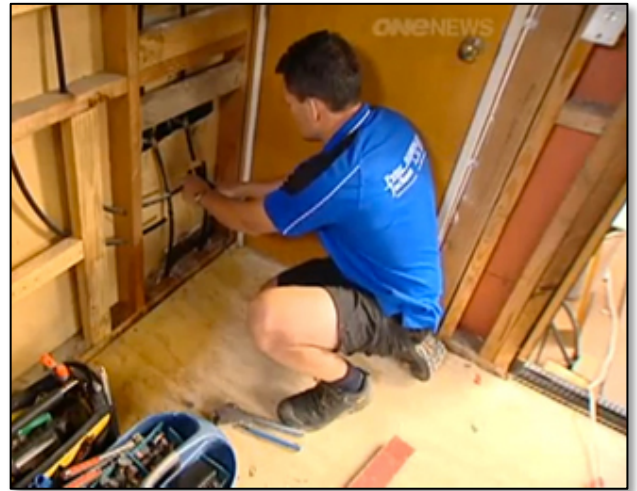
Given when it was manufactured, it is well out of the manufacturer's warranty period, and simply put it can leak, either by splitting down the length of the pipe or at the joints. Joints are crimped with a ring made from aluminium or copper. It has an increased risk of leaking if exposed to excess sunlight. Ideally it should not be exposed to sunlight for more than 30 days, which includes initial transport and installation times.

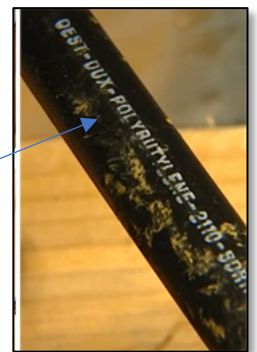
It is black with aluminium (silver coloured) or copper joints

It will have in white letters the name/brand "Dux Quest" or simply "Quest".
